# Handover Inspection Report

**Date of inspection:** 02 September 2025

**Property address:** Sample New Home, Brisbane QLD

**Builder:** Sample Builder Pty Ltd

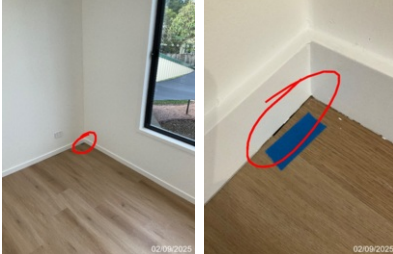
## 71 - Bed 2 - FLOORER

Rectify floorboard cut short in back left corner

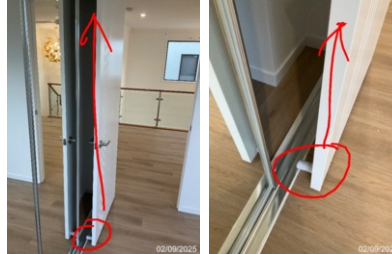
## 72 - Bed 2 - CARPENTER

Relocate door cushion stop to top of door and patch hole

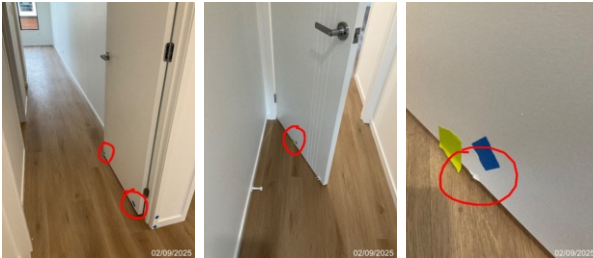
## 73 - Bed 3 - CARPENTER

Rectify burrs at base of door, both sides

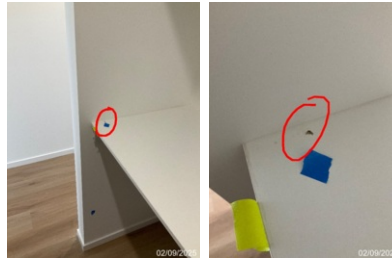
## 74 - Bed 3 - CABINET MAKER

WIR - Fit screw cover on lower shelf right of door

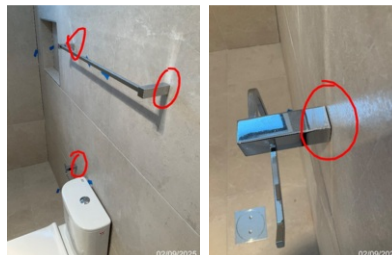
## 76 - Bed 3 - CARPENTER

Ensuite - Secure towel rail and toilet roll holder firmly to wall

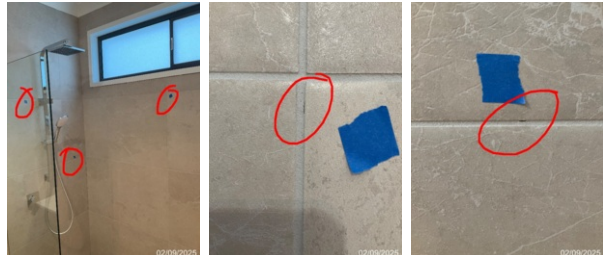
## 78 - Bed 3 - TILER

Ensuite - Point missing grout in shower, 3 locations

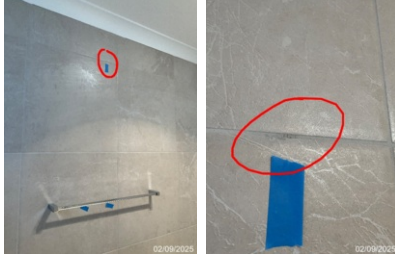
## 79 - Bed 3 - Tiler

Improve grout finish above top tile at towel rail

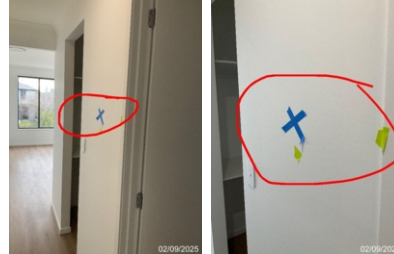
## 61 - Bed 4 - Plasterer

Improve plaster joint in wall between ensuite and WIR

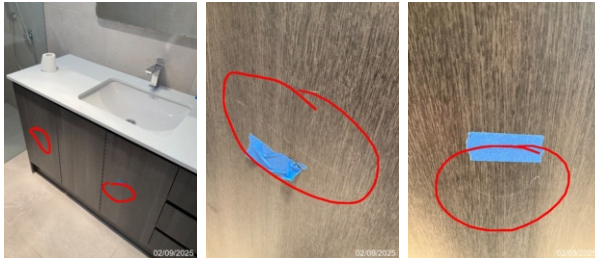
## 63 - Bed 4 - Cabinet Maker

Ensuite - Rectify scratches on 2 vanity cabinet doors

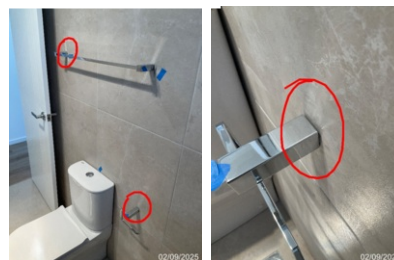
## 64 - Bed 4 - Carpenter

Ensuite - Secure toilet roll holder and left side of towel rail firmly to wall

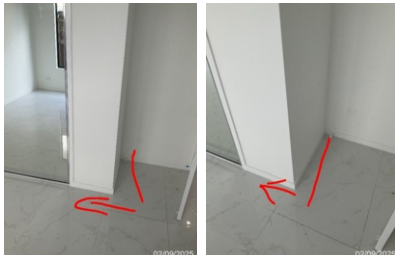
## 30 - Bed 5 - Carpenter

Wall on side of robe is not straight

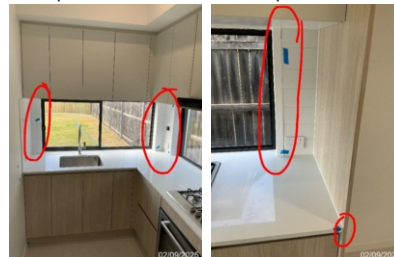
## 48 - Butler's Pantry - Silicone Installer

Complete silicone around splashback tiles and benchtop

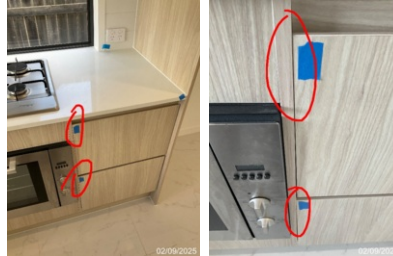
## 53 - Butler's Pantry - Cabinet Maker

Inconsistent spacing around right drawers

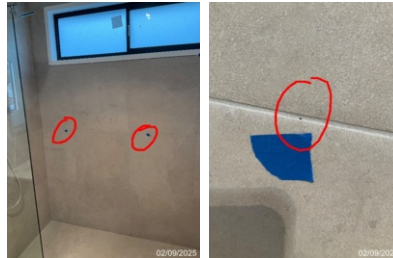
## 68 - Ensuite - Tiler

Point pinholes in shower wall tile grout

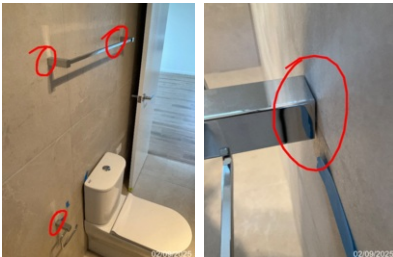
## 69 - Ensuite - Carpenter

Mount toilet roll holder and towel rail back to wall

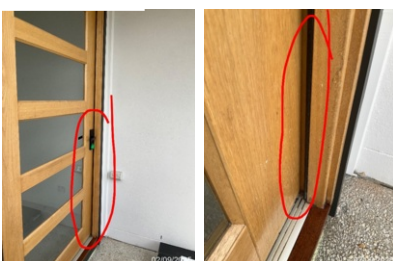
## 26 - Entry - Carpenter

Entry door is warped at base and does not meet the weather seal/door stop

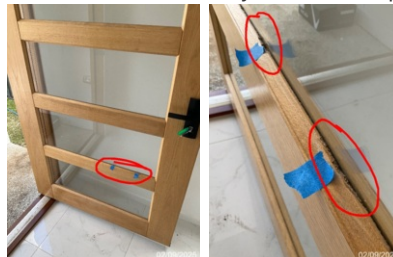
## 28 - Entry - Carpenter

Trim at base of 2nd entry door window panel is damaged

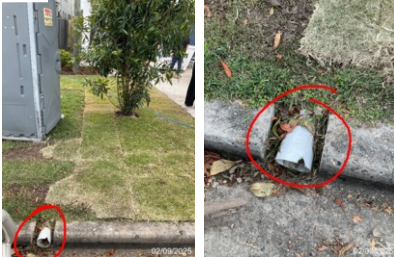
## 13 - Exterior - Plumber

Install kerb adaptor or concrete stormwater outlet at street to protect pipe

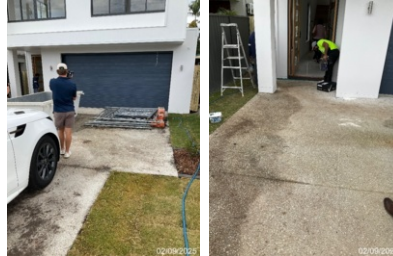
## 14 - Exterior - Cleaner

Clean all external surfaces

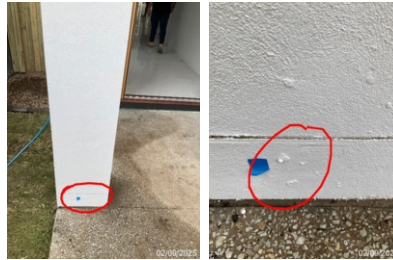
## 16 - Exterior - Renderer

Remove dags at base of front pier

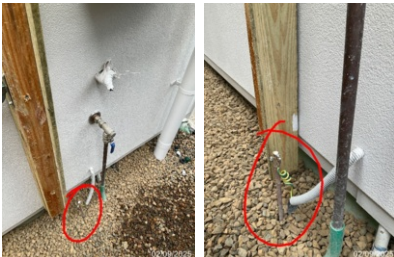
## 17 - Exterior - Electrician

Move earth stake closer to side of house

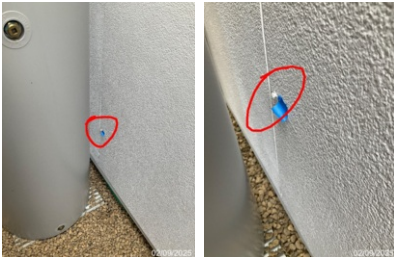
## 19 - Exterior - Carpenter

Knock down proud nail behind hot water system

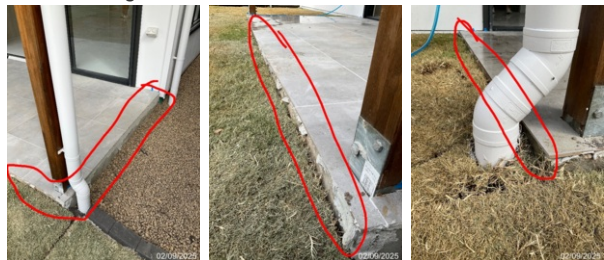
## 20 - Exterior - Tiler

Parge edges around patio, remove excess glue. Tile should not overhang.

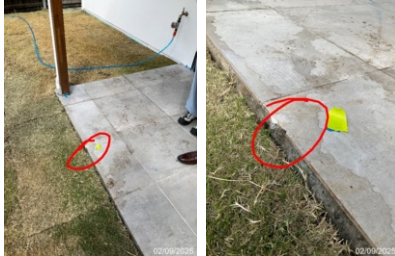
## 21 - Exterior - Tiler

Rectify chipped tile in patio

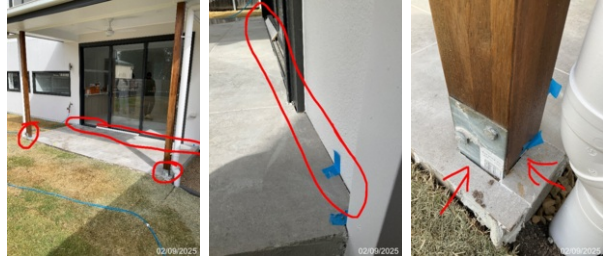
## 22 - Exterior - Silicone Installer

Complete silicone around patio tiles

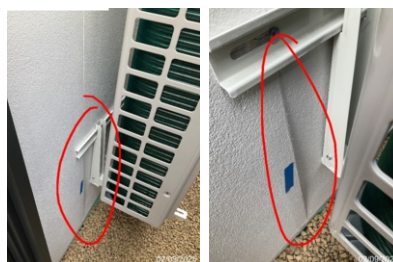
## 24 - Exterior - Carpenter

Sheeting is warped behind A/C and lacks timber support at base of bracket

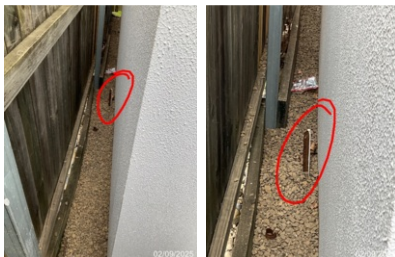
## 25 - Exterior - Supervisor

Remove star picket alongside built-to-boundary wall

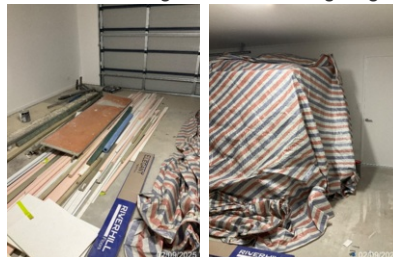
## 33 - Garage - Supervisor

Remove building materials from garage

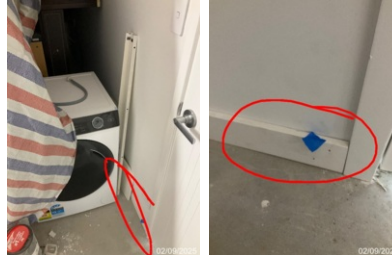
## 35 - Garage - Painter

Putty, seal and paint around skirting on internal door side of garage once building material has been removed

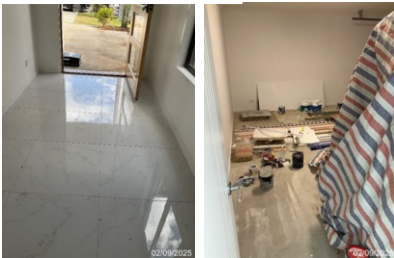
## 27 - General - Cleaner

Complete builder's clean

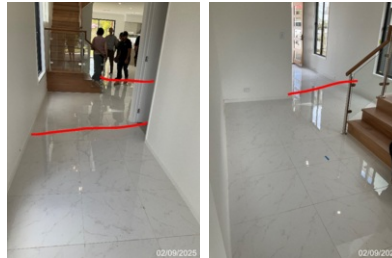
## 29 - General - Tiler

Control joints required in floor tiles every 4.5m

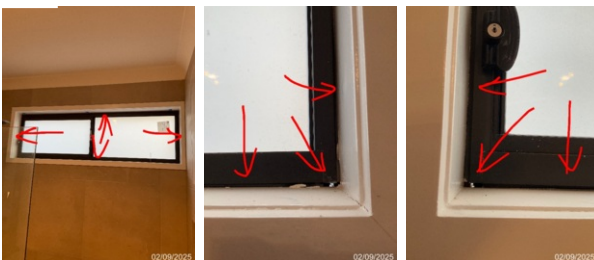
## 59 - General - Carpenter

In all wet areas, the window reveal has separated from the frame, leaving an excessive gap. Seal gaps and remove protruding nails.

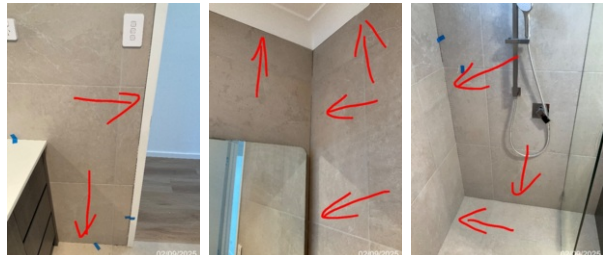
## 62 - General - Silicone Installer

Complete wet area silicone throughout

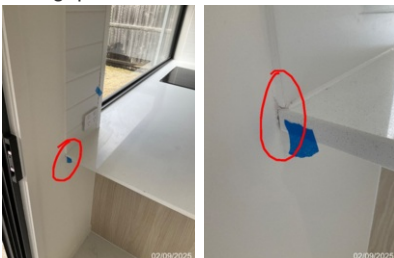
## 40 - Kitchen - Painter

Seal gap on left side of breakfast bar to wall

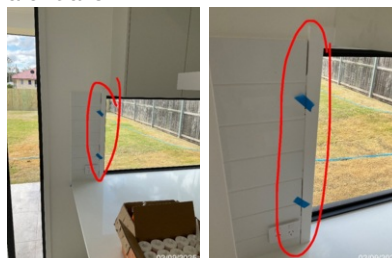
## 41 - Kitchen - Silicone Installer

Complete silicone on splashback tile left of window to architrave

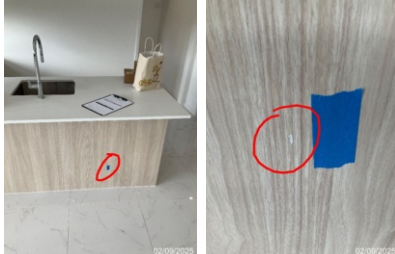
## 42 - Kitchen - Cabinet Maker

Barback panel is damaged right of sink

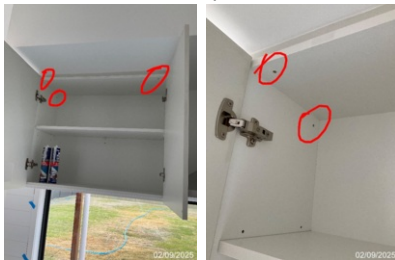
## 44 - Kitchen - Cabinet Maker

Fit screw covers at top of OH cabinet

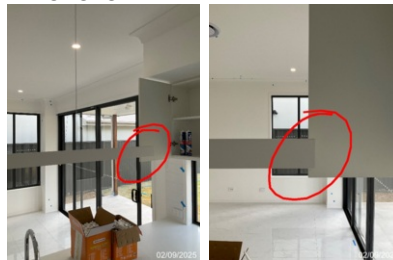
## 45 - Kitchen - Electrician

Hanging light binds with OH cabinet door

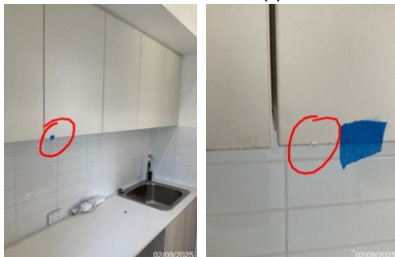
## 52 - Laundry - Cabinet Maker

2nd OH cabinet door is chipped at base

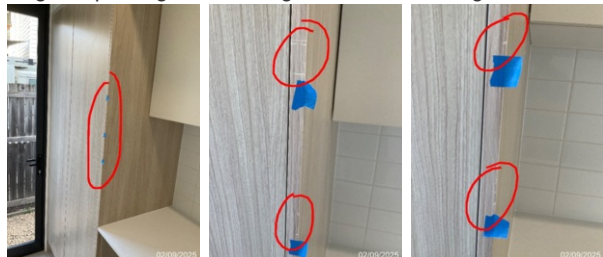
## 54 - Laundry - Cabinet Maker

Edge strip on right of full height cabinet is damaged

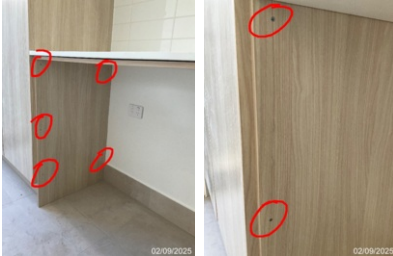
## 55 - Laundry - Cabinet Maker

Fit screw covers on washing machine opening below benchtop

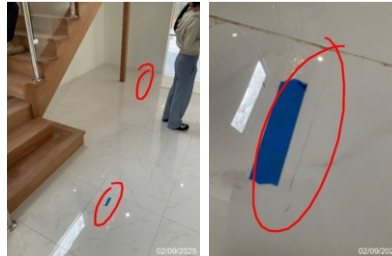
## 31 - Meals/Family - Tiler

Rectify marks on floor tiles. Clean floor and check for other marks

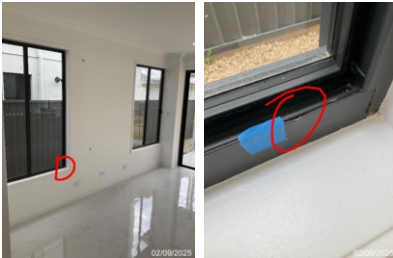
## 37 - Meals/Family - Glazier

Left sliding window frame is damaged at base

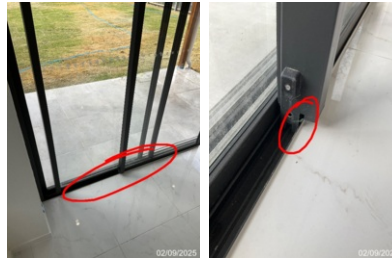
## 38 - Meals/Family - Glazier

Sliding door binds on bottom track when opening

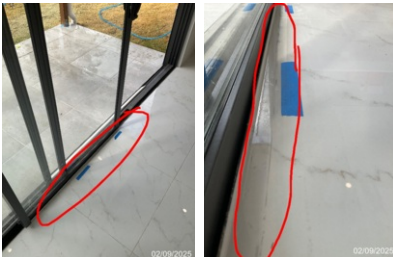
## 39 - Meals/Family - Tiler

Rectify marks on tiles adjacent sliding door

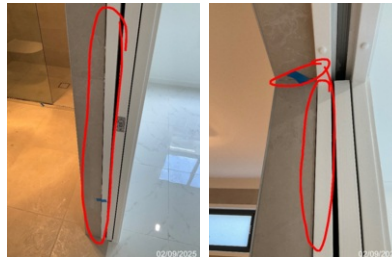
## 56 - Powder room - Silicone Installer

Complete silicone around wall tiles to bed 5

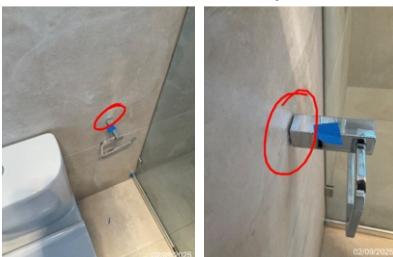
## 57 - Powder room - Carpenter

Secure toilet roll holder firmly to wall

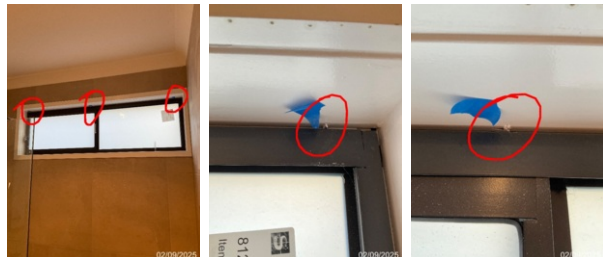
## 58 - Powder room - Carpenter

Remove missed nails above window

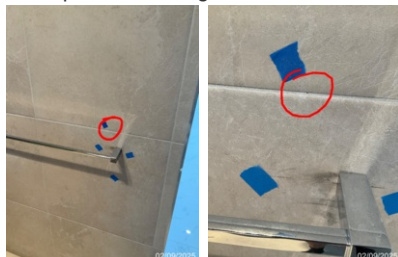
## 60 - Powder room - Tiler

Point pinhole in tile grout above towel rail

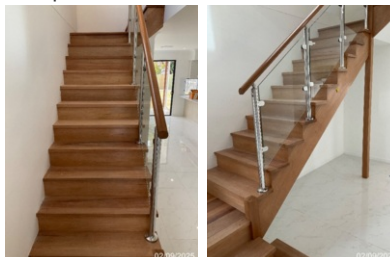
## 36 - Stairs - Painter

Complete final seal on stairs

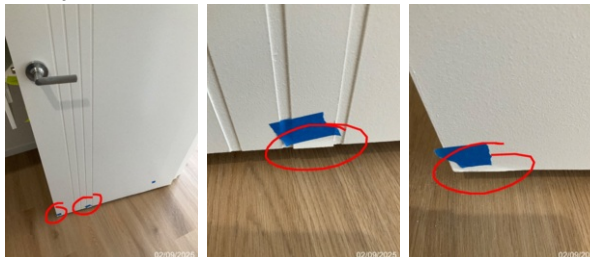
## 66 - WIR - Carpenter

Rectify burrs at base of door
