GOINSPECT PTY LTD  
ABN: 83 617 630 814  
QBCC License #15063854  
Ph: 07 3063 0793  
info@goinspect.com.au  
www.goinspect.com.au

## Frame Stage Inspection Report

**Property:** Anonymised sample house

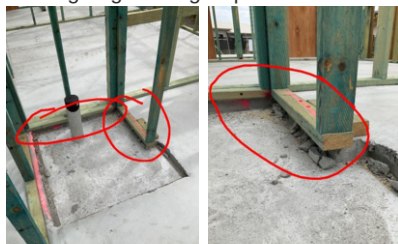
## #4 | Bathroom | Concreter

Bottom plate and stud lack adequate bearing at shower set-down. Wall framing is partially unsupported. Rectify to framing/engineering requirements.

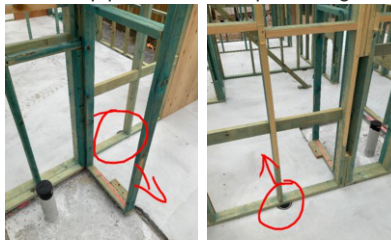
## #7 | Bathroom | Plumber

Waste pipe conflicts with wall frame. If reducer is insufficient, relocate pipe without compromising structure or termite barrier.

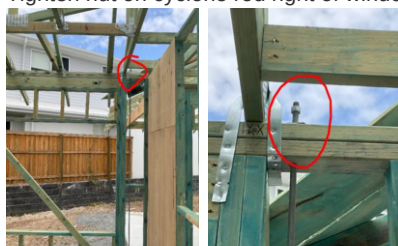
## #8 | Bed 2 | Carpenter

Tighten nut on cyclone rod right of window

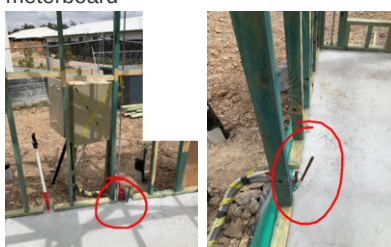
## #1 | Bed 4 | Concreter

Remove or relocate rebar protruding in living space at meterboard

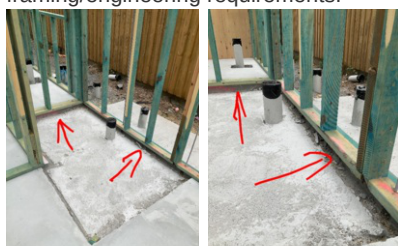
## #5 | Ensuite | Concreter

Bottom plate and stud lack adequate bearing at shower set-down. Wall framing is partially unsupported. Rectify to framing/engineering requirements.

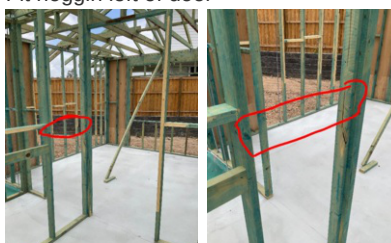
## #10 | Ensuite | Carpenter

Fit noggin left of door

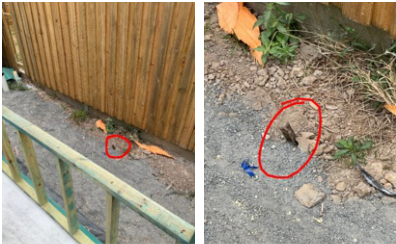
| <p><b>#14 Exterior Supervisor</b><br/>Remove star picket in ground 1m outside of bed 2 window, safety issue</p> | <p><b>#13 General Carpenter</b><br/>Install missing noggings to external walls where required. Where cyclone rods are fitted, ensure they are installed vertically.</p> |

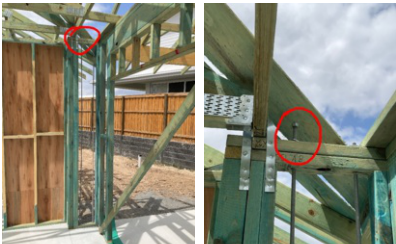
| <p><b>#2 Living Area Carpenter</b><br/>Tighten nut on cyclone rod left of sliding door</p> | <p><b>#12 WIR Carpenter</b><br/>Tighten nut on cyclone rod left of door</p> |
